CRESTED ICE

USAF B-52 Accident at Thule, Greenland, 21 January 1968

Report of Activities and Efforts by the Defense Atomic Support Agency Nuclear Emergency Team while TDY with the Strategic Air Command Disaster Control Team, from 22 January to 26 February 1968. Officer in Charge of the DASA NET, Captain Robert E. McElwee, U.S. Navy.

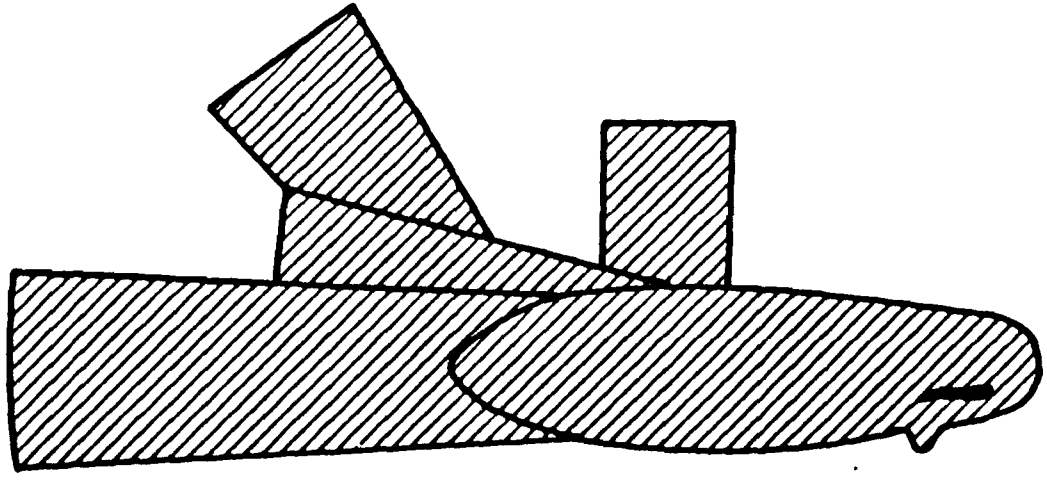
A four-man monitoring team, using PRM-5 instruments with SPA-3 Probes attached to a Trackmaster, searched inside the contamination-control line and 1 mile west of the line for weapons components. None were found. (See inclosure.)

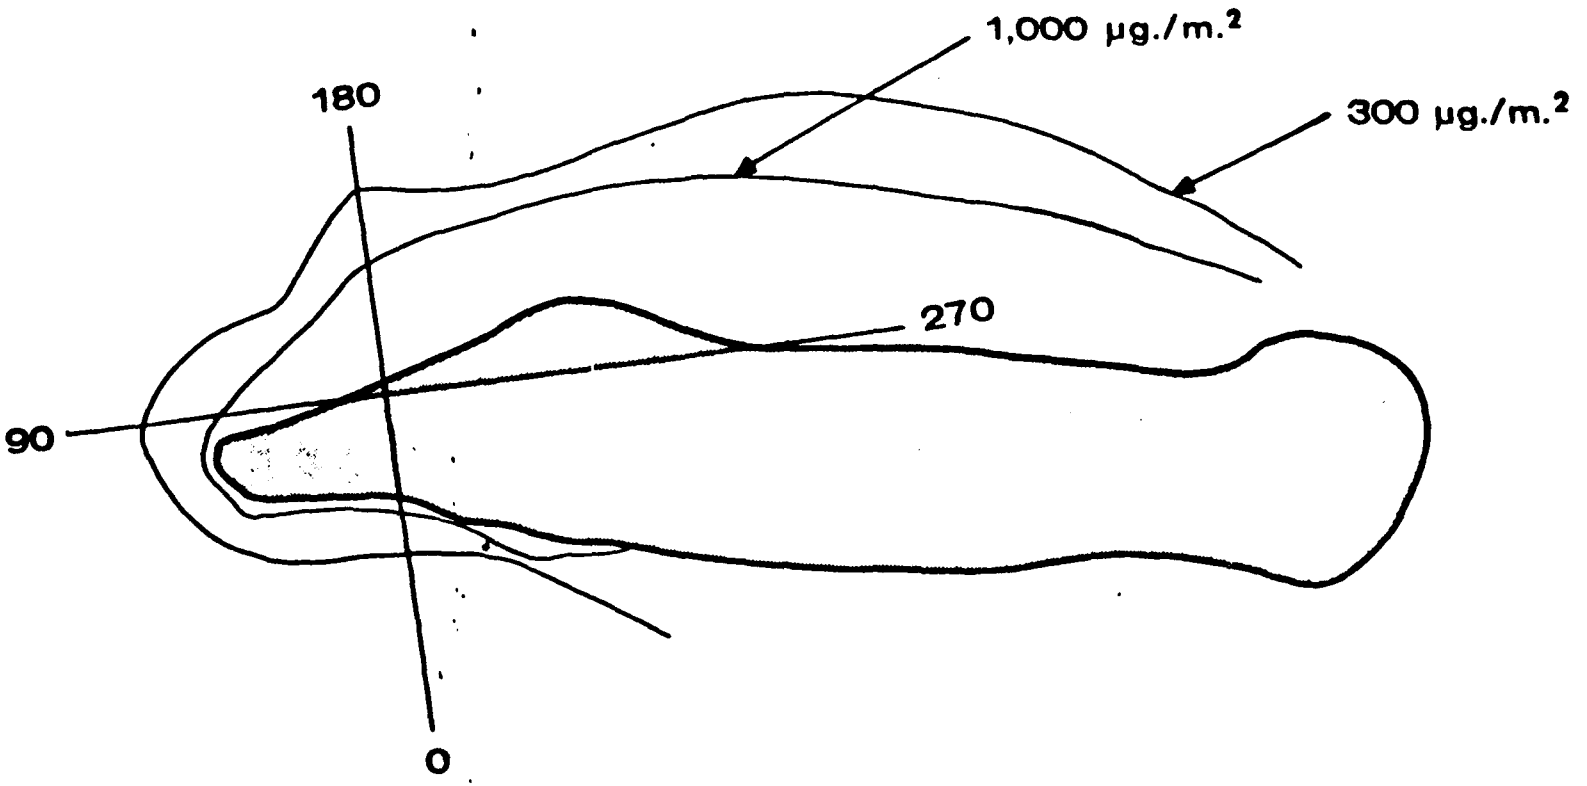
INITIAL RADIAL SURVEY
30° RADIALS

1 FEBRUARY 1968

RADIAL PLOT

Bearing of 0° Radial is 78°30' True

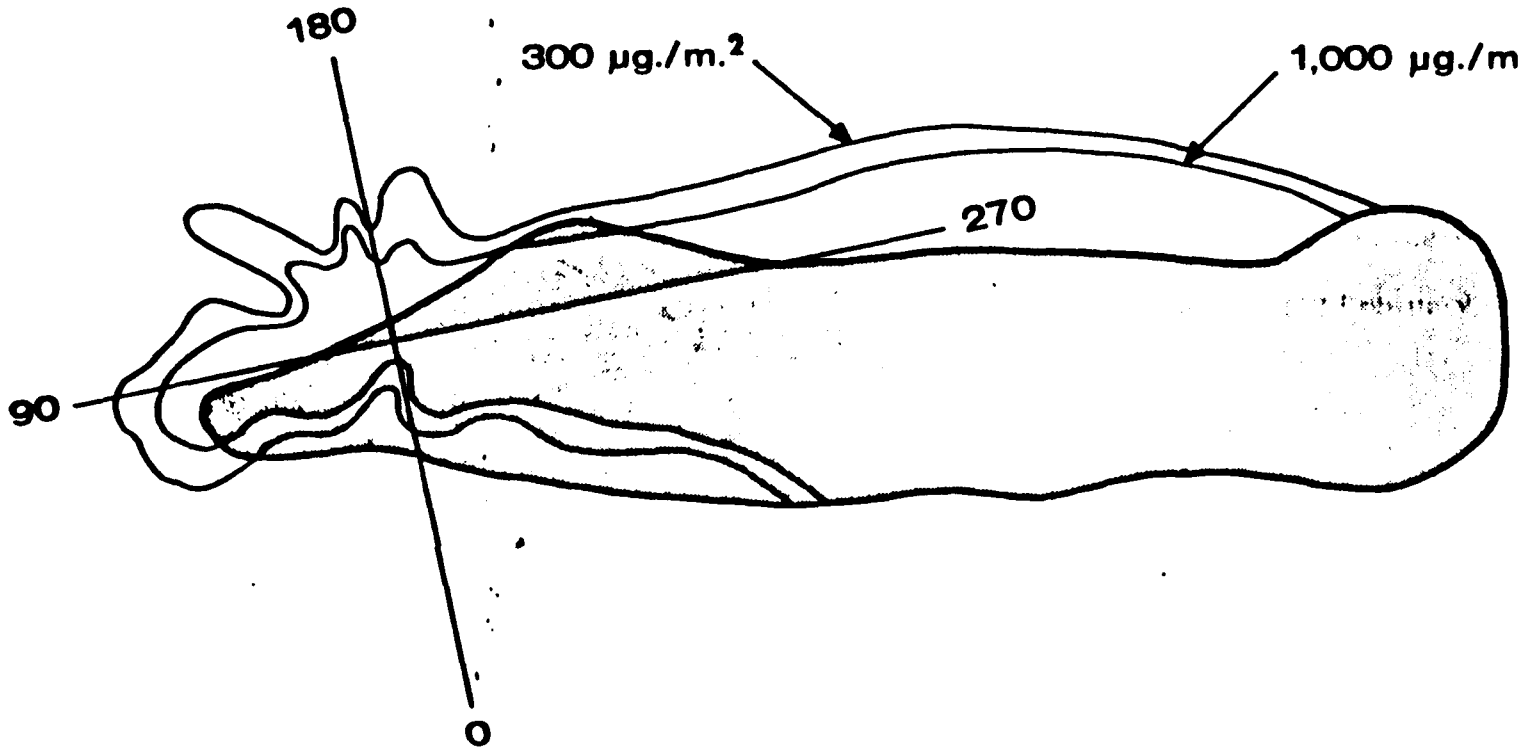
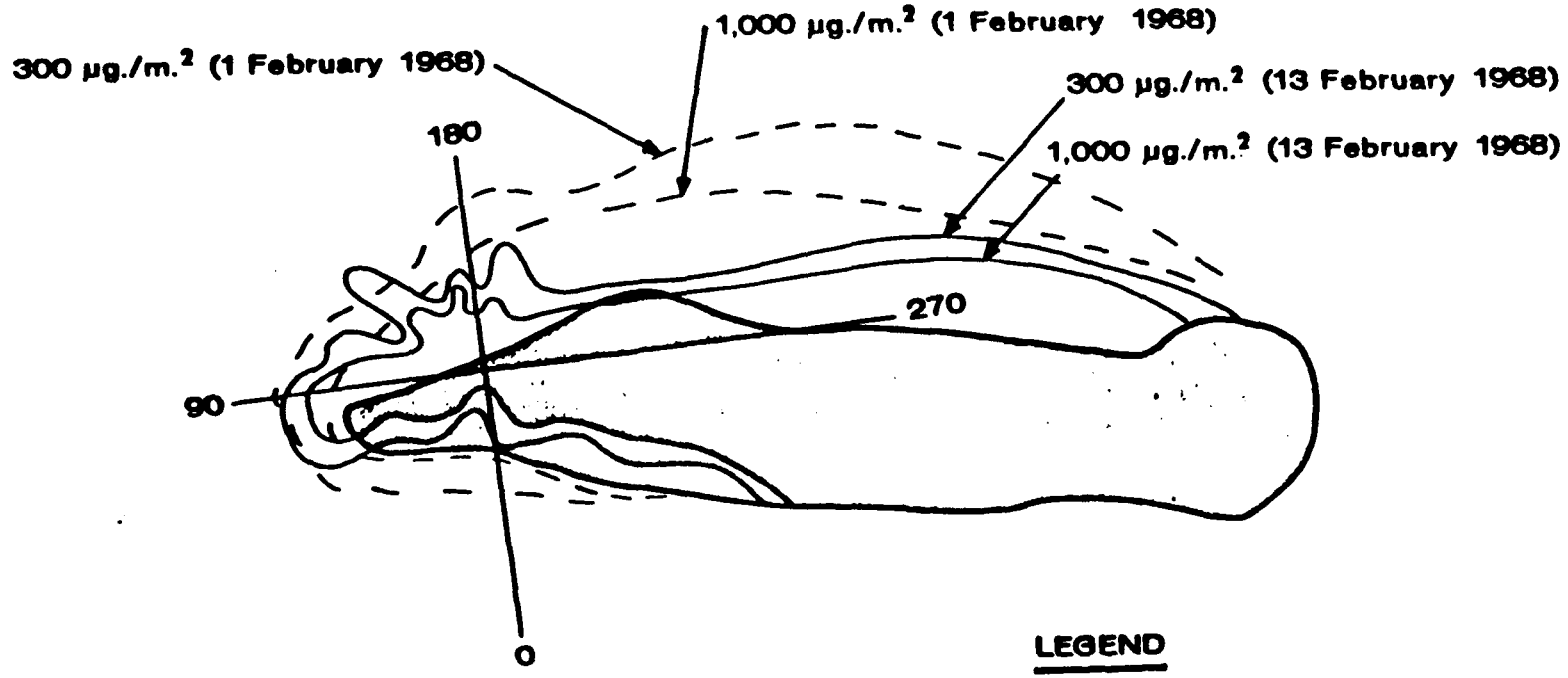
RADIAL PLOT

Bearing of 0° Radial is 78°30' True

Date of Survey - 13 February 1968

Contours in µg./m.²

Upper Broken Line - 300 µg./m.²
Lower Broken Line - 1,000 µg./m.²
Radial Run on 1 February 1968
